MARKETING BULLETIN

REPAIRING DAMAGE/DEFECTS IN A 2-HOUR AREA SEPARATION WALL SYSTEM

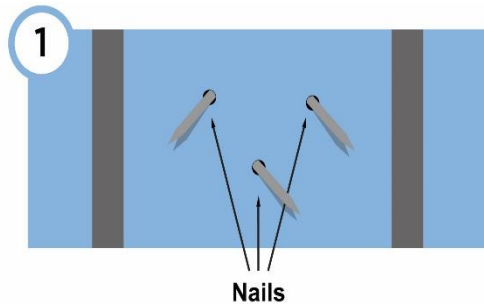
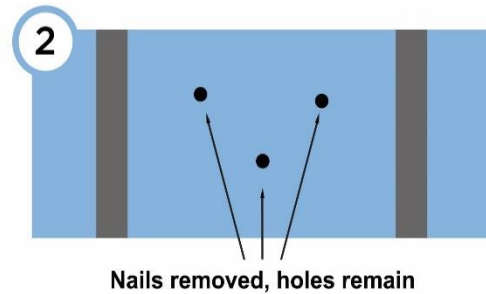
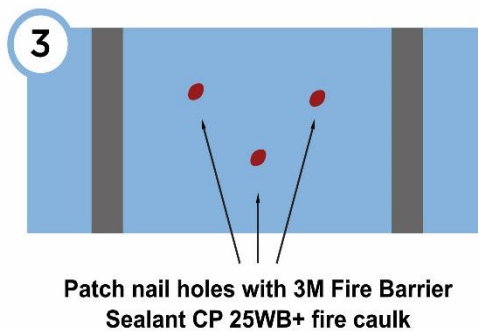
DAMAGE OR DEFECT:	NAILS DRIVEN THROUGH SHAFT LINER PANELS
--------------------------	--

ISSUE: Contractors have been known to drive or insert up to 16d nails into the 1" shaft Liner panels when building the ASW System. This practice voids the 2-hour fire rating.

- REPAIR:**
- ❖ Remove the nails from the panels
 - ❖ Fill holes with 3M Fire Barrier Sealant CP 25 WB+ fire caulk (both sides of the wall where applicable)
 - ❖ Smooth out fire caulking with putty knife or like tool
