TECHNICAL SERVICES BULLETIN

REPAIRING DAMAGE/DEFECTS IN A 2-HOUR AREA SEPARATION WALL SYSTEM

DAMAGE OR DEFECT:	H-STUDS INSTALLED HORIZONTALLY IN AN AREA SEPARATION WALL SYSTEM
--------------------------	---

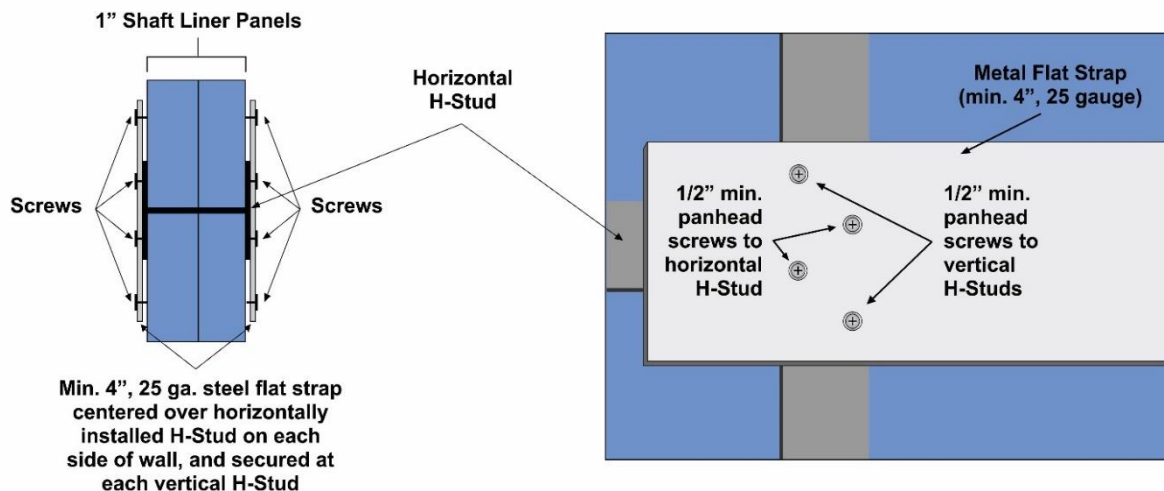
ISSUE: At times during the installation of the Area Separation Wall System, a framing crew will mistakenly install an H-Stud horizontally - instead of the required 2" C-Runner Track, to cap or finish off a wall section. This error during installation does void the fire rating of the ASW System, but American Gypsum - working with UL, has developed the following corrective action to restore the 2 hour fire rating.

REPAIR: When "H" studs are erroneously installed horizontally to cap the Area Separation Wall in lieu of 2" C-Runner Tracks, do the following:

- ❑ As shown in the detail below, secure a minimum 4" wide metal flat strap (min. 25 gauge) the full length of the horizontally installed H-Stud - on each side of the wall.
- ❑ Ensure that the metal flat strap is centered over the horizontal "H" stud, and attach with four (4) 1/2 in. min long panhead screws, at the location of the vertical H-Stud
- ❑ Two (2) of the screws are used to secure flat strap to vertical "H" stud
- ❑ The other two (2) screws are used to secure the metal flat strap to the horizontal "H" stud, in alternating pattern
