REPAIR OF JOINT RIDGING (GA-221-14)

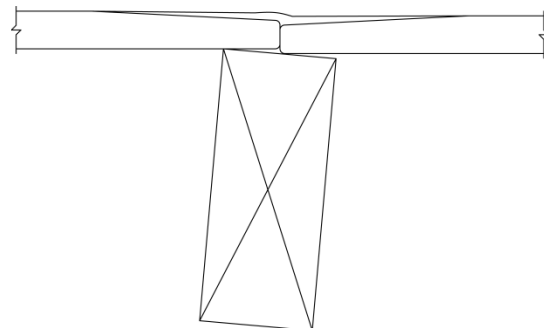
Typical Joint After Ridging

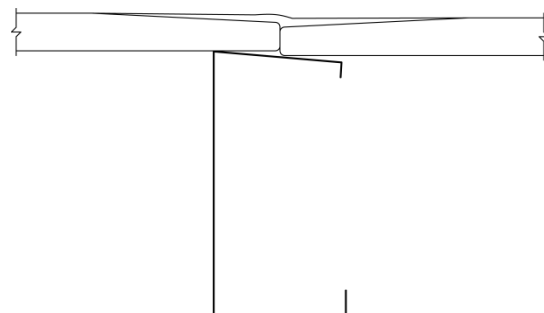
Ridging can also be caused by misaligned framing or by repeated changes in temperature or humidity, either of which can induce stresses in the board that are relieved when one or both gypsum boards is compressed and bulge outward at the joint.

Typical Ridge From Misaligned Framing

Lightly sand the ridge down, taking care not to damage the embedded joint reinforcing tape. Fill the surface over the area being treated with joint compound, feathering as wide as necessary to create an essentially flat surface. Allow drying-type joint compound to dry for at least 24 hours before proceeding. Setting-type joint compound must be set before proceeding to the next coat of joint compound but must be dry before painting. Refer to the manufacturer's specifications for the setting times of various setting-type joint compounds.

After the joint compound is dry, it may be lightly sanded to feather the edges and remove any remaining tool marks. Examine the sanded area to determine whether or not the ridge has been eliminated. If the examination indicates that the ridge has not been adequately concealed, additional feathering coats of joint compound may be required. Allow each coat of joint compound to dry at least 24 hours before sanding (if not using setting-type compound).

The repaired joint should be painted with a coat of drywall primer and allowed to dry thoroughly prior to the application of final decoration.
