## GA-221-2019

### CAUSES, PREVENTION, AND REPAIR OF JOINT RIDGING AND CENTERLINE CRACKING

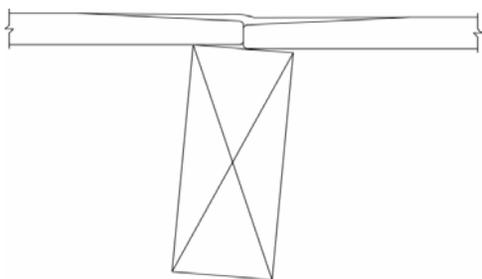
- Improper application of gypsum panels is another cause of joint ridging and centerline cracking. In many but not all cases, the ridges and cracks from improper installation are visible soon after the joints have dried or cured.
- Fastening gypsum panel products to warped or misaligned studs is a significant cause of ridging and cracking.
- Improper fastening of gypsum panel products to steel studs can bend a stud and cause a ridge.
- Improper preparation and finishing of butt joints can cause ridges or cracks.
- Panels installed at doorframes and windows with joints located closer than 12 in. (300 mm) to the corner are prone to cracking.
- The practice of “belly banding” is another cause of ridging and cracking.

**Typical Ridge From  
Warped/Misaligned Framing**

Inspect framing for warped or twisted studs, proper alignment, and proper spacing to identify areas with the potential for ridging or cracking. Proper procedures and workmanship during installation of framing and during installation of gypsum panels will minimize issues due to misaligned framing.

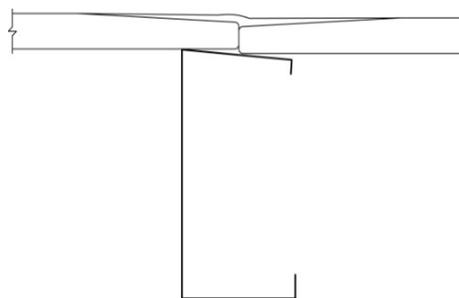
**Typical Ridge From Bent Framing**
